Buyers Guide to: Volkswagen Type 25

Background

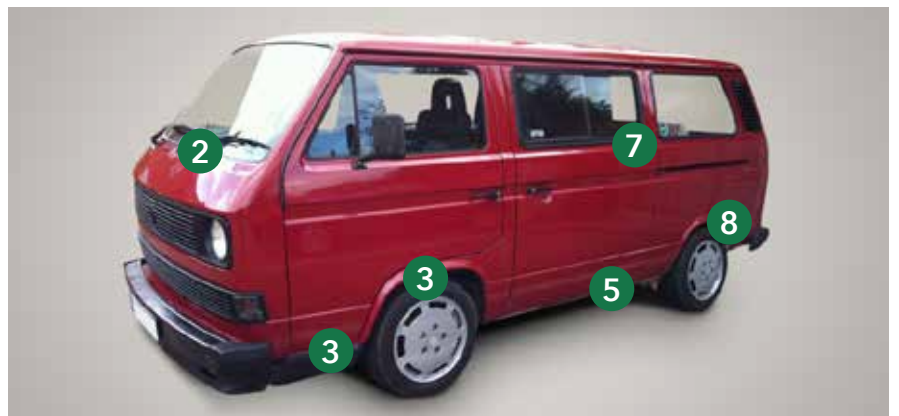
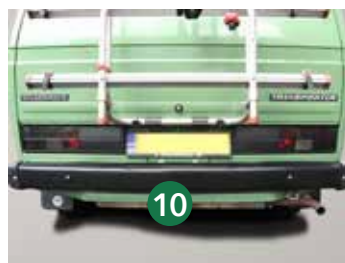
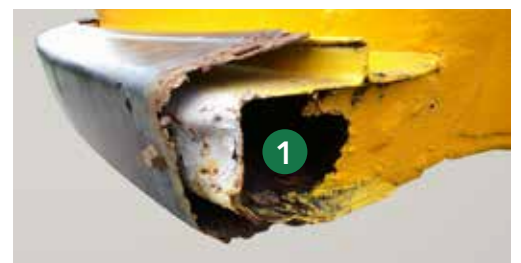
Corrosion Hotspots

1. Outer front panel behind the bumper
2. Front screen surround
3. Door bottoms and front steps
4. Floorpan
5. Inner and outer sills
6. Chassis legs including outriggers
7. Side window surrounds
8. Rear quarter panels and wheel arches
9. Rear swing arm mounts and spring seats
10. Rear valance and bottom of the tailgate

- The panels for rust around the edges, and pay particular attention to seams and panel joints as they harbour rot which can spread into the structure
- Around the edges of the windscreen and side windows, if fitted. Rust bubbles can be tricky to repair, and serious rot could have eaten away the metalwork beneath the rubbers with expensive consequences
